Thompson Pump Dewaterers a Part of the Kansas River

Thompson Pump's Kansas City Branch representative was called to provide assistance on a pump upgrade on an existing raw water intake structure project on the Kansas River, in Johnson County, Kansas.

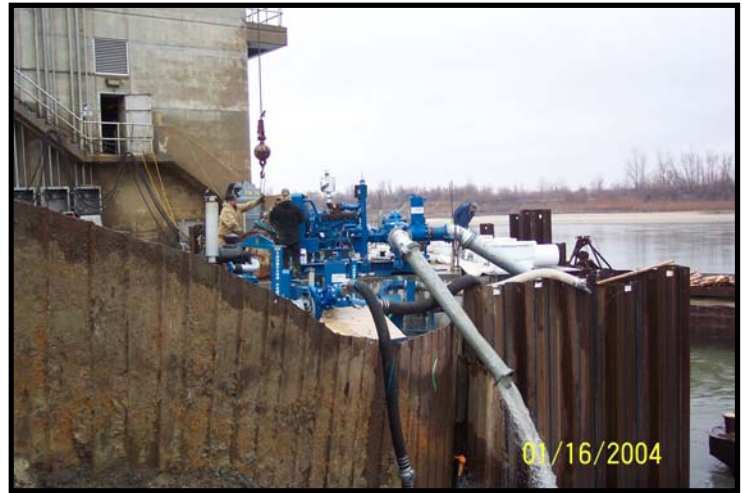
Thompson pumps dewatering the coffer dam to allow crews to make repairs to the Johnson County Water Treatment Plant.

The contractor installed sheet piling around the area to block off the section of the river to be pumped, and to dewater the area where work was to take place. Although the sheet piling was installed deep enough to hit bedrock, a large amount of river water was still entering through the sheet piling at the riverbed.

Thompson Pump's Kansas City Branch representative provided four units to help successfully dewater the coffer dam:

- A Thompson 6-inch Compressor-Assisted Open Trash/Sewage Pump with *ENVIROPRIME*[®] Priming System, capable of a maximum of 1,750-gallons per minute,
- A Thompson 6-inch Compressor-Assisted Solids Handling High Pressure Pump with *ENVIROPRIME*[®] Priming System, capable of a maximum of 2,550-gallons per minute,
- A Thompson 12-inch Compressor-Assisted Solids Handling High Pressure Pump with *ENVIROPRIME*[®] Priming System, capable of a maximum of 7,500-gallons per minute,
- And, a 6-inch electric submersible pump.

Thompson Pump was able to immediately supply all of the pumps along with other accessories, such as Thompson Galvanized Pipe, directly from their branch location. All of the pumps were started first thing in the morning as crews arrived at the Water Treatment Plant in order to remove the river water than collected in the coffer dam overnight. With all four pumps operating, the coffer dam would be successfully dewatered in 30-minutes. Once the dewatering was complete, the repair crews would then enter the coffer dam and begin their repairs. At that time, the Thompson 6-inch Compressor-Assisted Open Trash/Sewage Pump and the Thompson 6-inch Compressor-Assisted Solids Handling High Pressure Pump were turned off, leaving the Thompson 12-inch Compressor-Assisted Solids Handling High Pressure Pump and the 6-inch electric submersible pump operating to maintain dryness in the coffer dam as repairs were made throughout the day.
