Application Engineering Bulletin

Heavy Rains Cause Major Problems Along Roswell Road

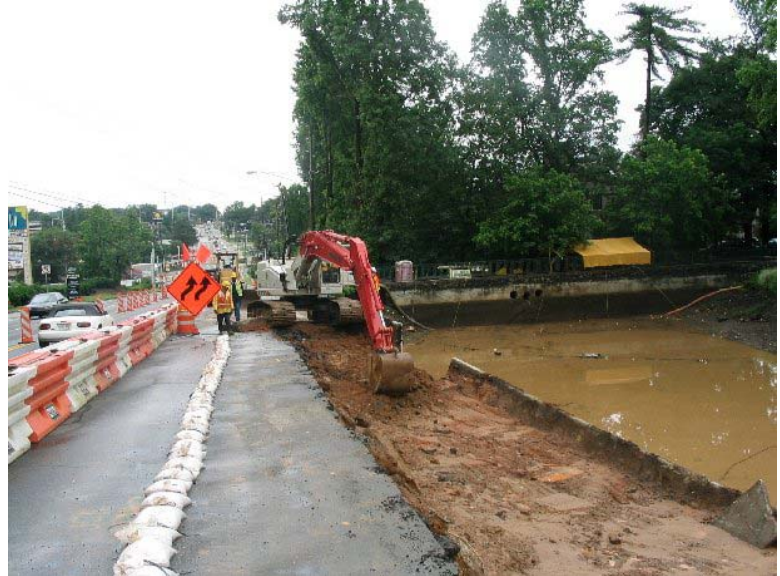
Heavy rains caused Roswell Road to crack and collapse causing the retention wall along the lake to collapse as well, causing flooding on the heavily traveled northbound lanes.

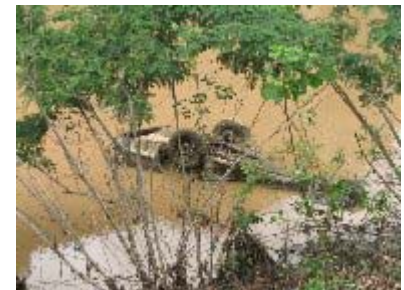
A trailer that fell into the retention pond when Roswell Road collapsed.

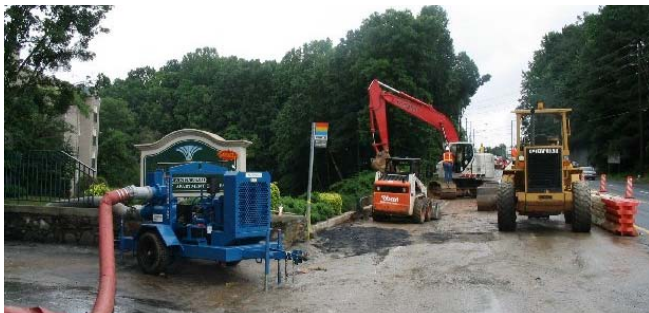
GDOT crews repair Roswell Road while a Thompson Pump 8-inch Dry Prime Compressor-Assisted Trash Pump dewatering the four acre lake.

Hamsley had two Thompson model 8TSC 8-inch Dry Prime Compressor Assisted Trash Pumps brought over from the local Thompson rental fleet warehouse. Once operational, the pumps Hamsley selected pumped 5,000 gallons per minute out of the lake. The lake water was redirected to an area several hundred yards away, where the ground water level was not as high and there was no threat to any nearby structures.

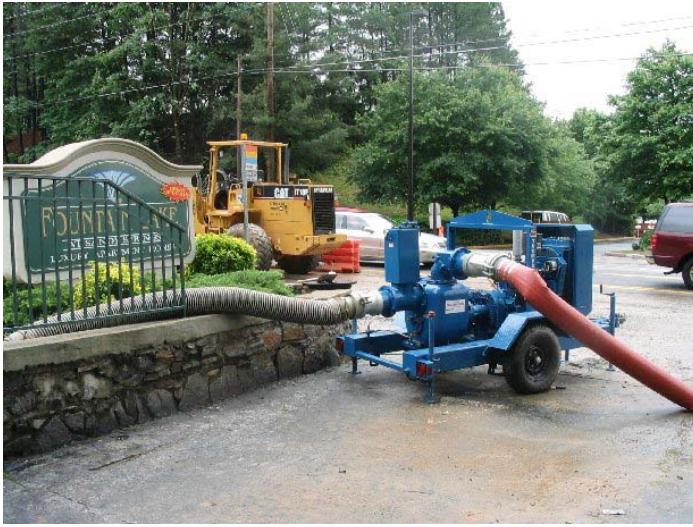
Thompson Pump's 8-inch Dry Prime Compressor-Assisted Trash Pump reduces the flooding threatening Fountain Lake Apartments

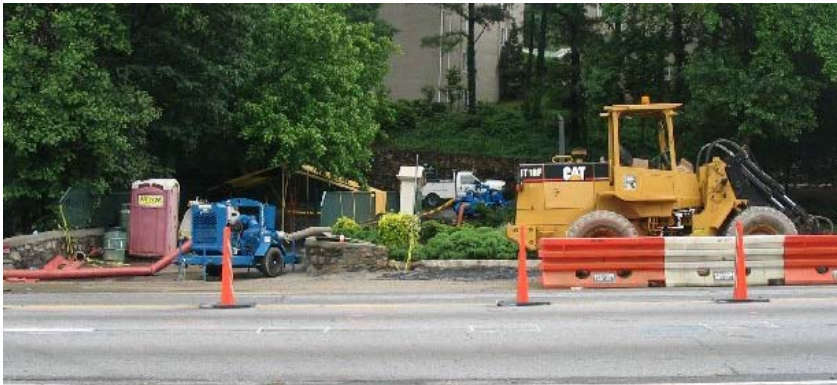
The quick response by Thompson Pump allowed GDOT crews to begin repairs to Roswell Road and the retention wall bringing traffic back up-to-speed.

The quick response by Thompson Pump to lower the water level in the lake allowed Rogers Bridge Company to get below the foundation of the retention wall and begin work on a new retention wall. The retention wall was approximately 240 feet long where it had collapsed along Roswell Road.
